Jetstream® CPX-1000 Release Notes

Release 3.3.0.1

Document Number 1000-A2-GK41-40
April 2004

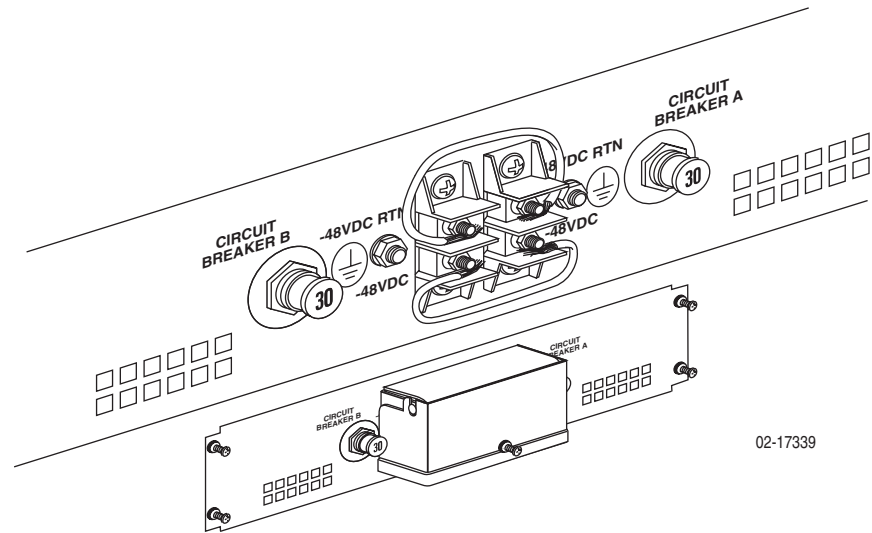
Some models of the CPX-1000 are shipping with a different type of PDU than the one shown in the user documentation.

The new PDU contains two plunger-type circuit breakers instead of one double-pole switch. To remove power from the PDU, pull each circuit breaker plunger out. To apply power to the PDU, push each circuit breaker plunger completely in and release.

The new PDU is shown below.
