Jetstream[®] CPX-1000 Release Notes

Release 3.3

Document Number 1000-A2-GK41-30
November 2003

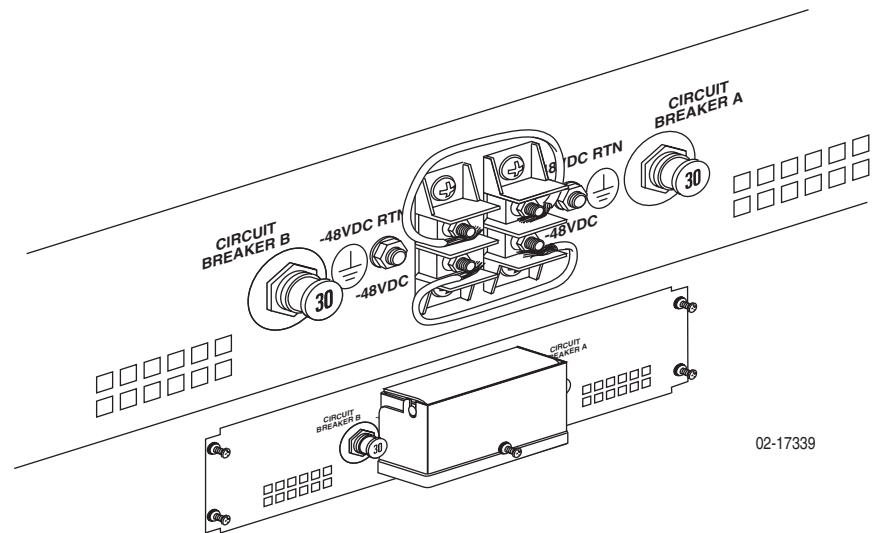
Some models of the CPX-1000 are shipped with a different type of PDU than the one shown in the user documentation.

The new PDU contains two plunger-type circuit breakers instead of one double-pole switch. To remove power from the PDU, pull each circuit breaker plunger out. To apply power to the PDU, push each circuit breaker plunger completely in and release.

The new PDU is shown below.
