Hotwire™ DSLAM for 8000 MCC and 8540/8546 DSL Cards Firmware Update Description, Release 2.03.15

Document Number 8000-A2-GK52-00

This document contains information that been added in the Hotwire™ Models 8540 and 8546 DSLAM (Digital Subscriber Line Access Multiplexer) system as a result of Firmware Release 2.03.15. This document is to be used in conjunction with the following documentation:

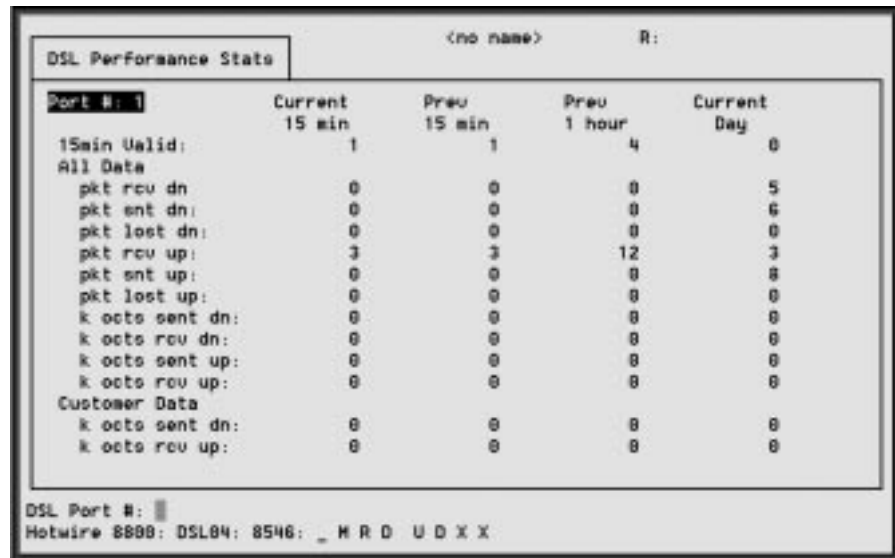
DSL Performance Stats

Two fields have been added to this screen under **Customer Data**:

- **k octs sent dn** – Displays the number of octets (in thousands) of customer data sent by the DSL card to the endpoint.
- **k octs rcv up** – Displays the number of octets (in thousands) of customer data received by the DSL card from the endpoint.

The screenshot shows a terminal window titled "DSL Performance Stats" with a sub-header "(no name) R:". The main content is a table with the following structure:

Port # 1	Current 15 min	Preu 15 min	Preu 1 hour	Current Day
15min Valid:	1	1	4	0
All Data				
pkt rcv dn:	0	0	0	5
pkt sent dn:	0	0	0	6
pkt lost dn:	0	0	0	0
pkt rcv up:	3	3	12	3
pkt sent up:	0	0	0	8
pkt lost up:	0	0	0	0
k octs sent dn:	0	0	0	0
k octs rcv dn:	0	0	0	0
k octs sent up:	0	0	0	0
k octs rcv up:	0	0	0	0
Customer Data				
k octs sent dn:	0	0	0	0
k octs rcv up:	0	0	0	0

At the bottom of the screen, there is a label "DSL Port #:" followed by a cursor, and a line of text: "Hotwire 8800: DSL04: 8546: _ M R D U D X X".

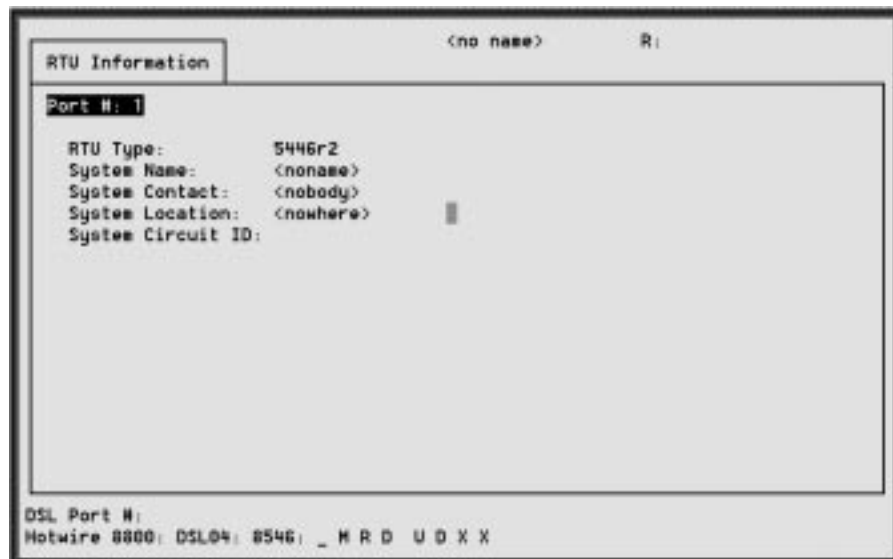
RTU Information

One field has been added to this screen:

- **System Circuit ID** – 32 characters. Displays the circuit ID of the Remote Termination Unit (RTU).

When you are connected to an RTU, the **CAP Rev** field appears on the screen.
